**WALLACE LAKE DAM  
CARTER COUNTY, MISSOURI  
MO 31263**

**PHASE 1 INSPECTION REPORT  
NATIONAL DAM SAFETY PROGRAM**

WALLACE LAKE DAM  
CARTER COUNTY, MISSOURI  
MISSOURI INVENTORY NO. 31263

PHASE I INSPECTION REPORT  
NATIONAL DAM SAFETY PROGRAM

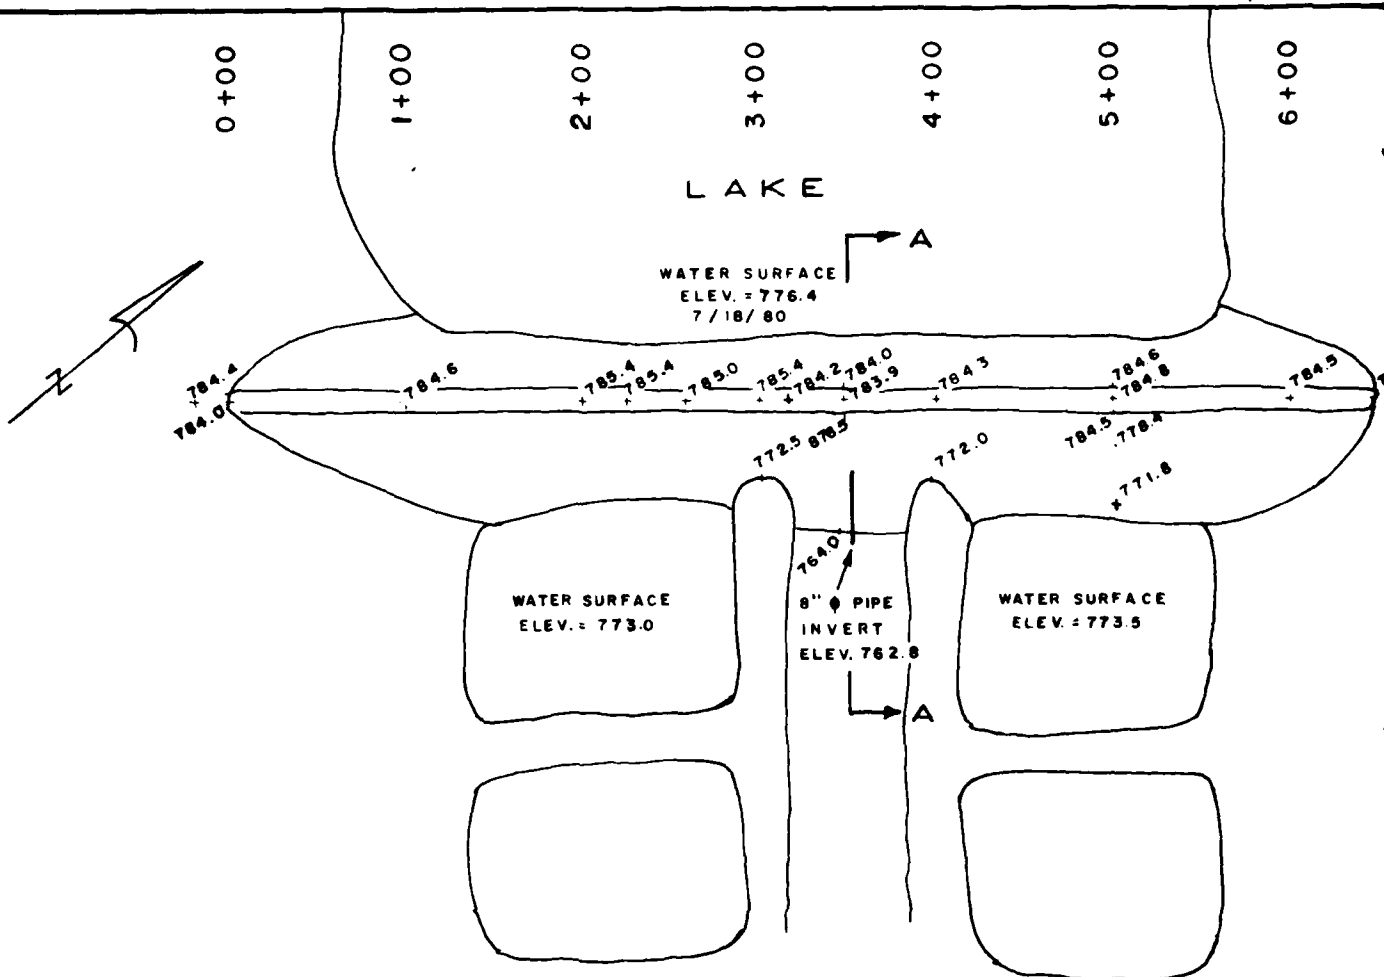
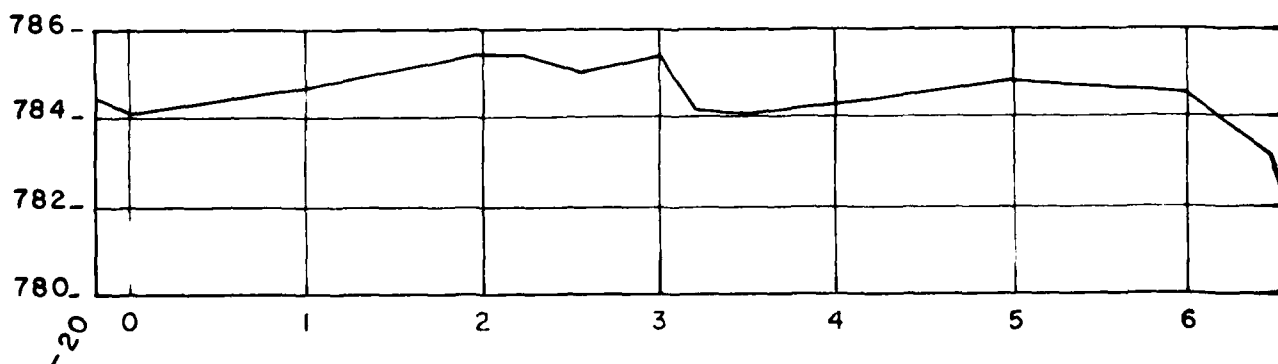
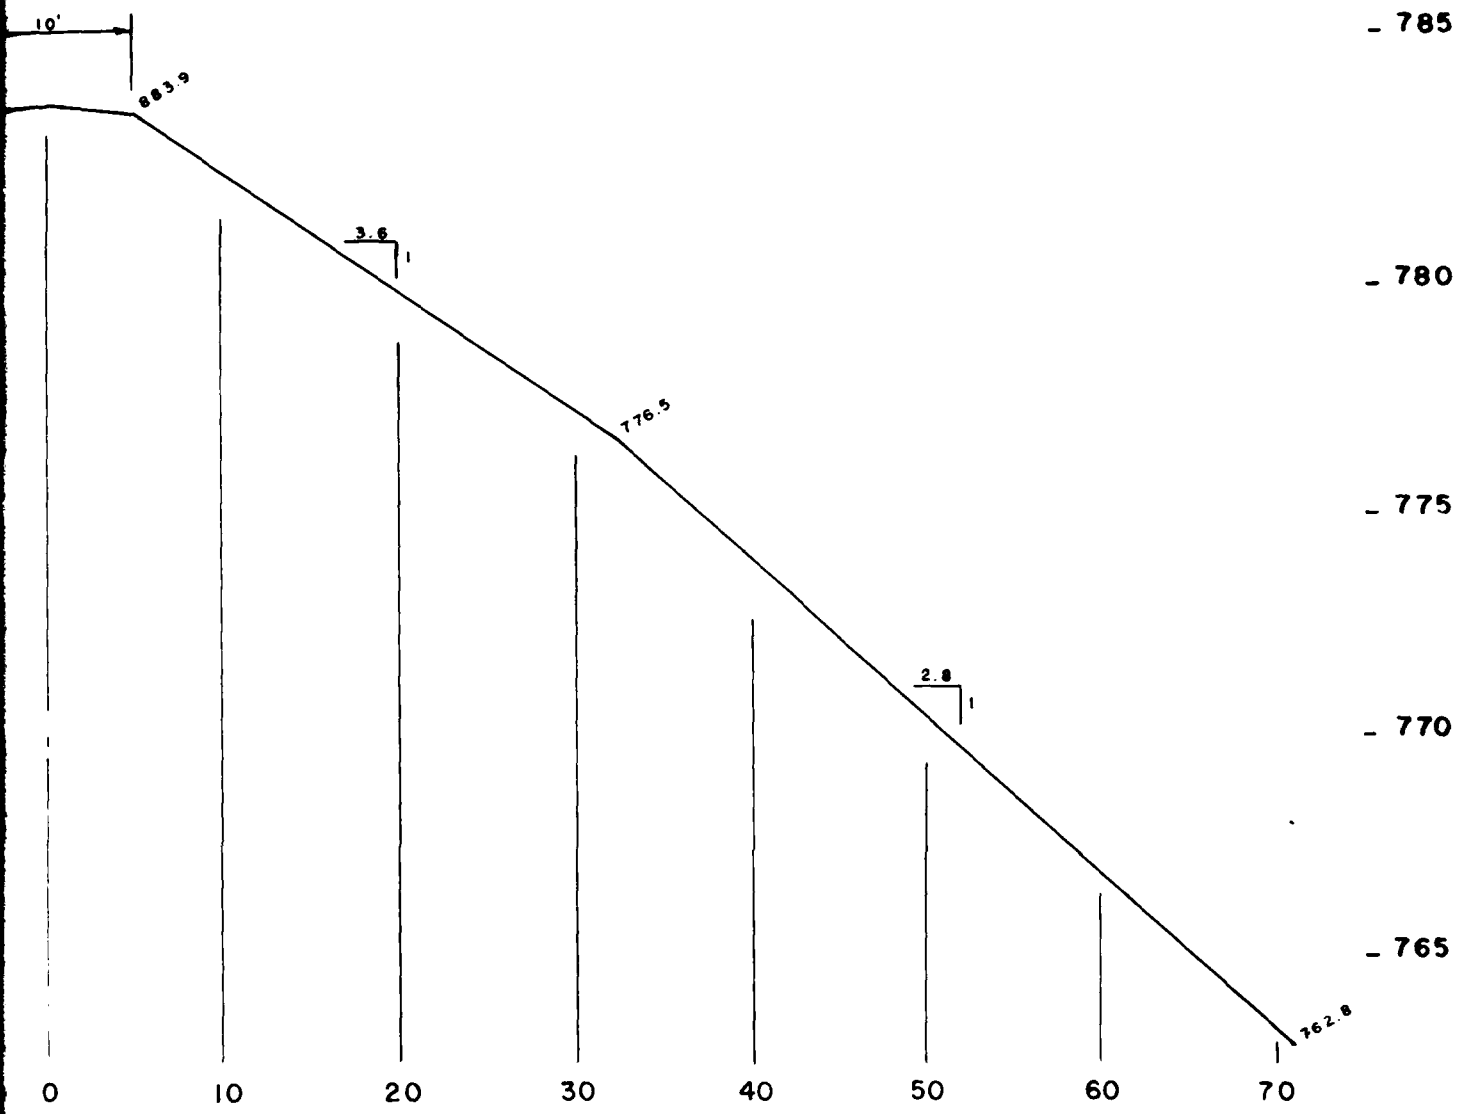
SHEET 3 APPENDIX A

BENCHMARK:  
ROCK AT STA 0+00  
CENTER OF DAM  
ELEV. 784.0

ON A - A STA 3+50

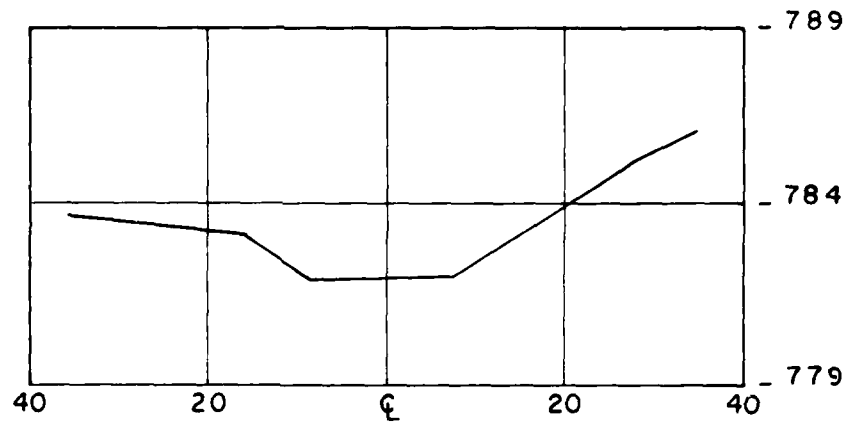
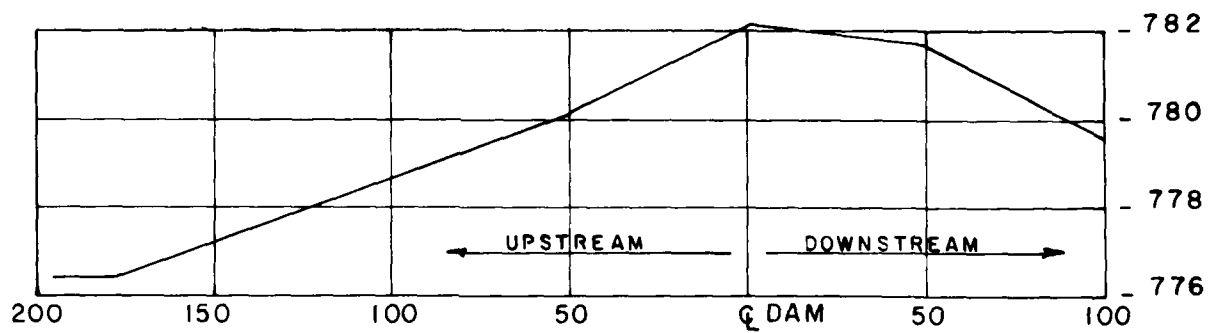
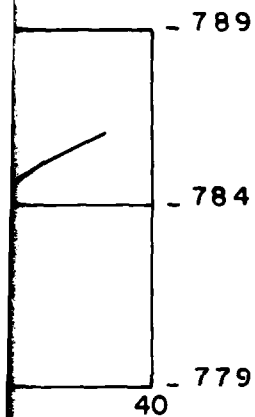
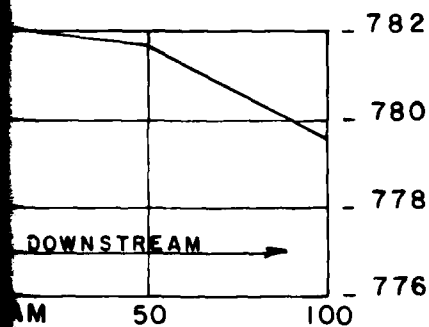
SHEET 3A APPENDIX A

SPILLWAY SECTION  $\phi$  DAM

SPILLWAY PROFILE

SPILLWAY  
SECTION & PROFILE

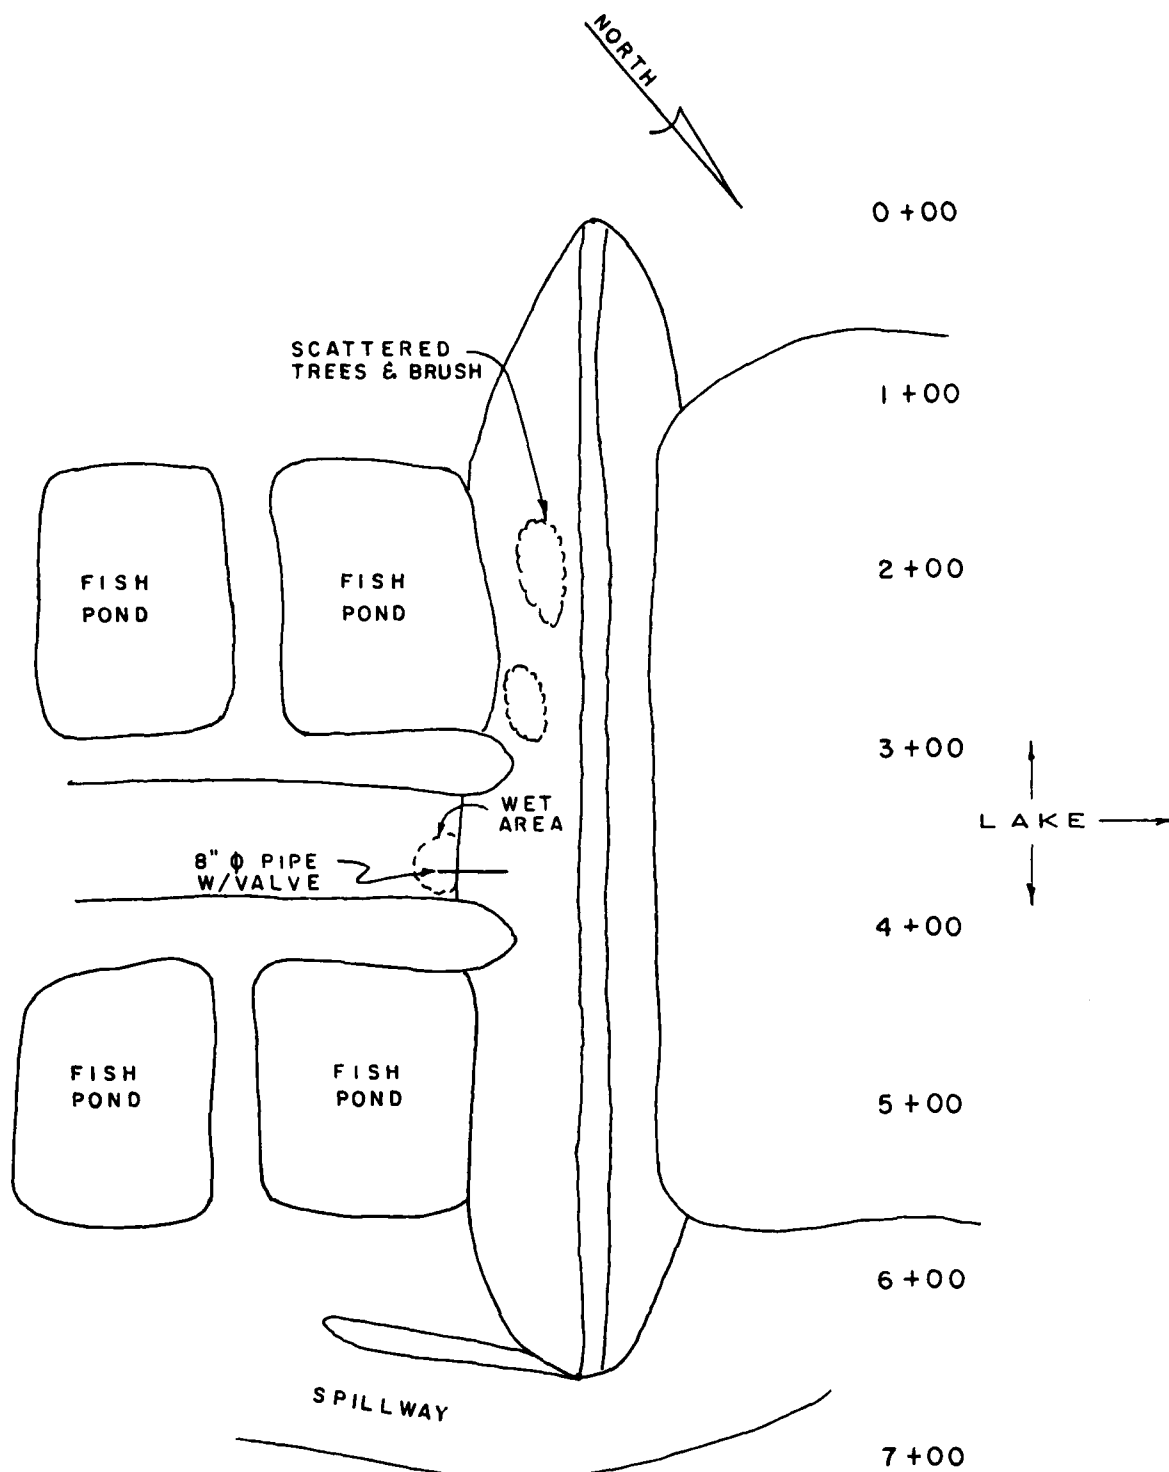
PLAN SKETCH OF DAM  
WALLACE LAKE DAM  
MO. No. 31263
